CLIENTS : AMBIKA DREDGING LIMITED

EQUIPMENT : SHAFT

SERVICE : DYNAMIC BALANCING OF FOUR SHAFTS

DYNAMIC BALANCING OF FOUR (4) SHAFT

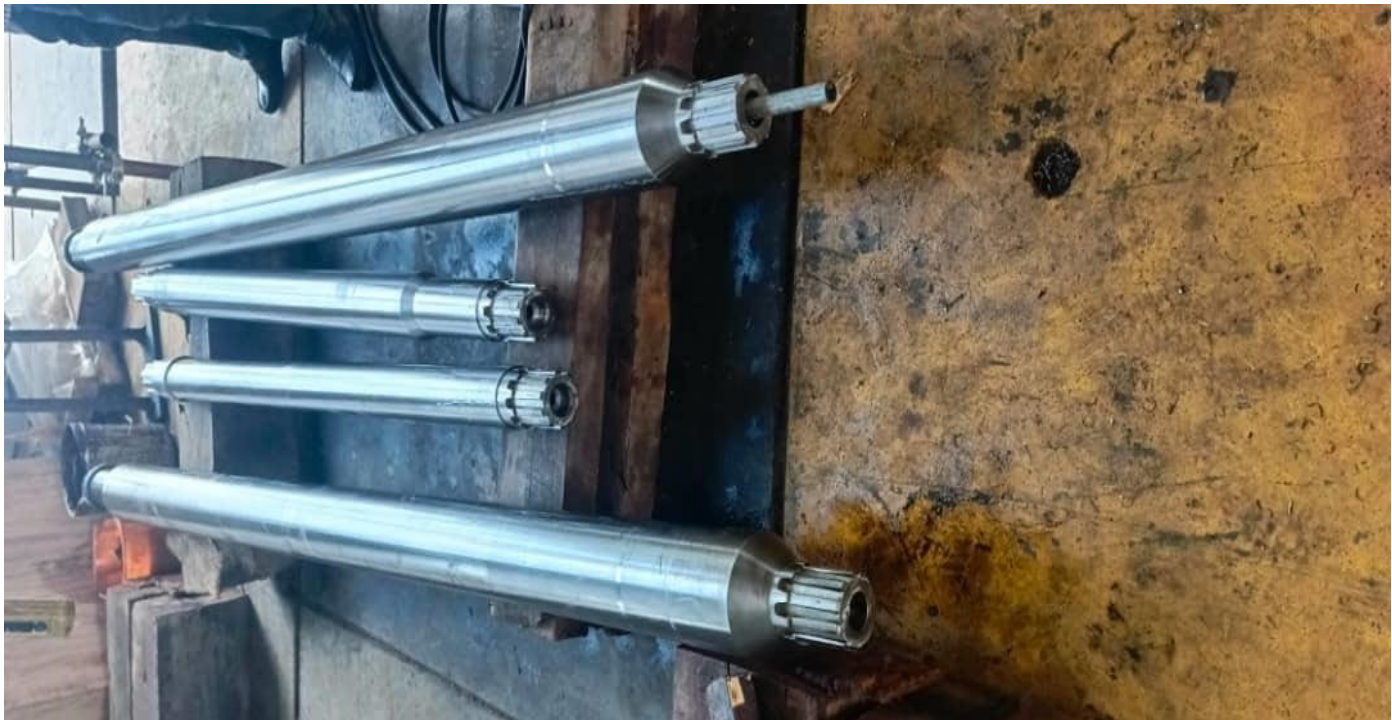
PICTURE OF SHAFT BELOW

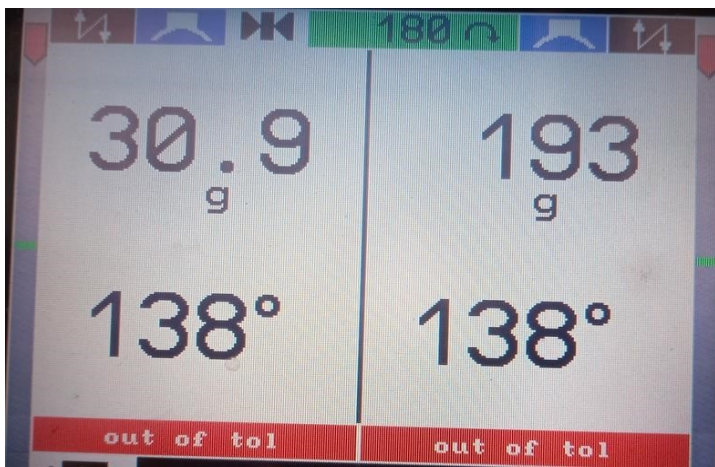
- Cleaning shafts and removing high spot
- Taken the shaft weigh, 170kg
- shaft set up on dynamic balancing machine
- Visual inspection on the rotor ☐ Balancing machine set up
- Test run the initial ..... shown on picture below,
- **OUT OF TOLERANCE.** ☐ Continued removing the unrequired weight until the shaft is **WITHIN TOLERANCE** ☐ **FINAL** run shows shafts **WITHIN TOLERANCE.**

INITIAL READING RUN OUT

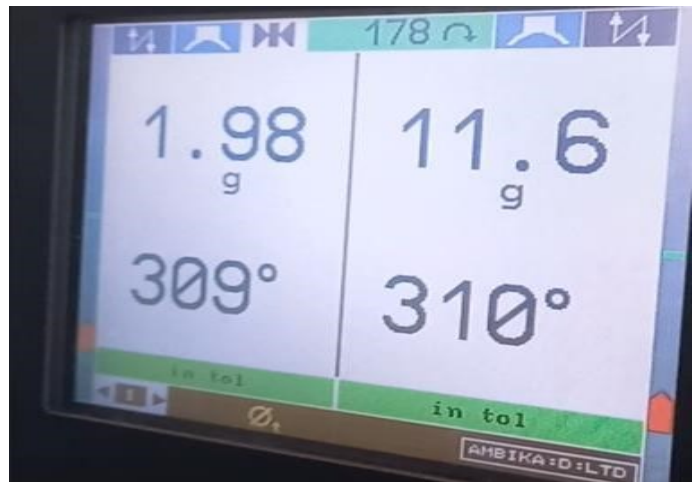
Shafts are within the **ACCEPTABLE TOLERANCE.**

FINAL READING RUN OUT

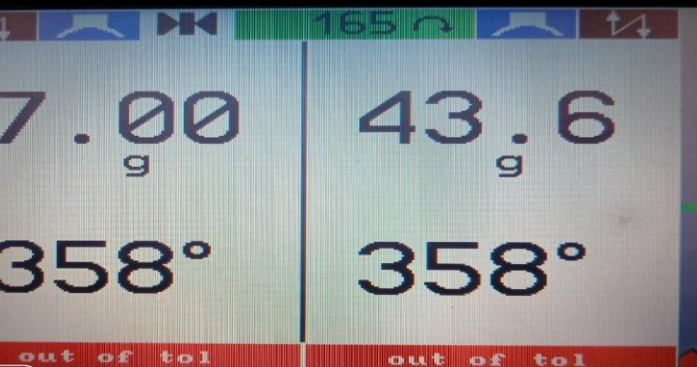
- Cleaning shaft and removing high spot
- Shaft weigh, 440kg
- Set up shaft on balancing machine
- Visual inspection on the rotor
- Balancing machine set up
- Test run the **initial** ..... shown on the picture, **out of tolerance**. ☐ Continued adding the required weight until the shaft is within tolerance ☐ **Final** run shown that the shaft is **within tolerance**.

INITIAL READING.

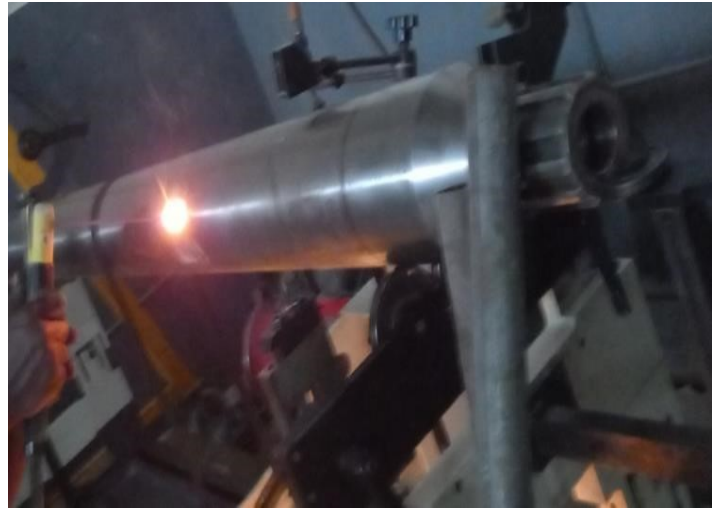
Adding required weight to shaft

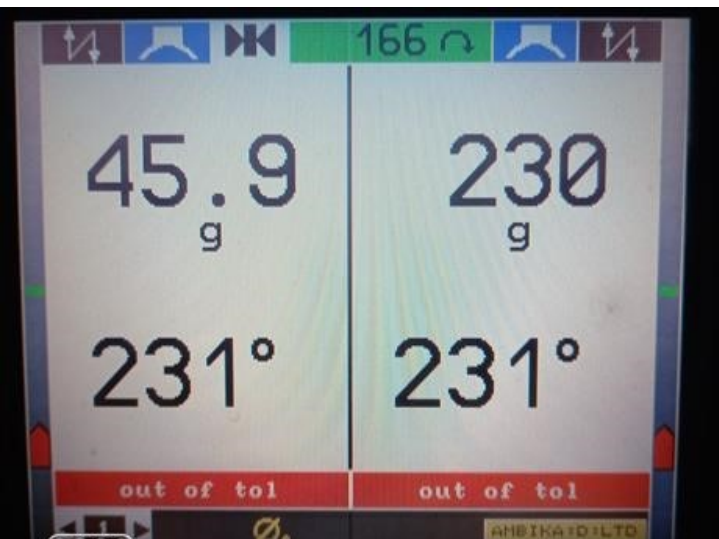
- Cleaning shaft and removing high spot
- Shaft weight, 128kg
- Set up shaft on balancing machine
- Visual inspection on the rotor ☐ Balancing machine set up
- Test run the **INITIAL** ..... shown on the picture, **OUT OF TOLERANCE**. ☐ Continued removing the required weight until the shaft is **WITHIN TOLERANCE** ☐ **FINAL** run shown that the shaft is **WITHIN TOLERANCE**.

INITIAL READINGS
